Editorial

REPORTS ...

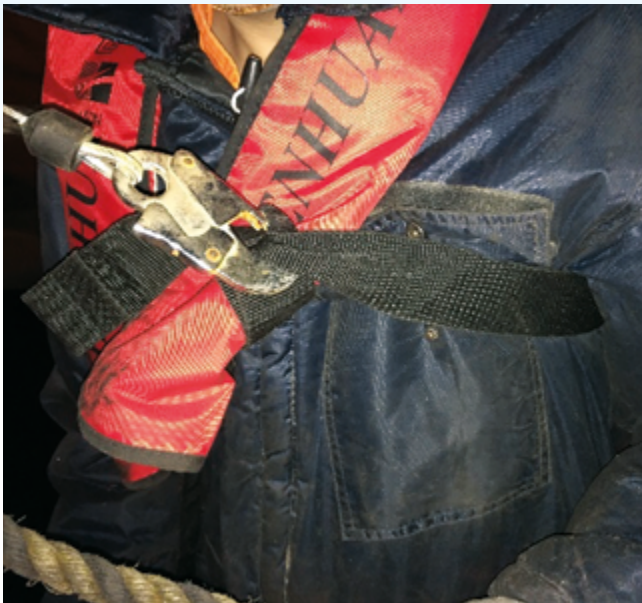
Lifejacket with safety lanyard.

Rigging the gangway, the crew were dutifully using inertia-wire rope safety lanyards clipped to the webbing straps of life jackets. There were a few issues of concern and I don't believe they are unique to this vessel.

- The lifejacket was not of a type designed for fall arrest. (Lanyard clipped around strap and strap around torso).
- There was no energy absorbing lanyard in use.
- There was no obvious rescue means on hand at the top of the work area.
- The inertia-wire rope unit was not directly above the worker. Should they have fallen they would have suffered the pendulum effect. The wire was passing over a sharp coaming.
- The inertia unit was secured to handrails that were in poor condition.

There are many factors here, including the design of a gangway area that seems to have no regard for how to rig safely. The idea that someone is expected to walk down a gangway with no rails and then lift those rails into place shows that good human-centred design has a long way to go in our industry.

The Maritime Advisory Board agreed with all aspects of this report. It is good example of Human Centred Design not being applied, forcing crews to work around the problem. Designers take note!

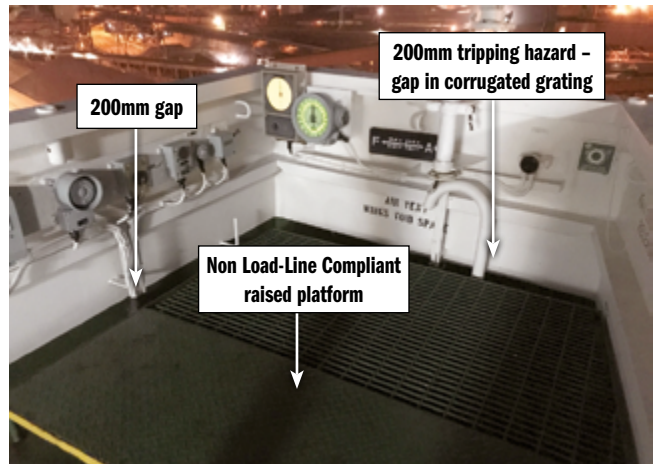
I piloted a vessel into port this morning. As I walked out to the bridge wing in the dark I was confronted by a platform approximately 200mm off the deck - despite the yellow paint on the edge it was almost invisible. Once on the platform I had the coaming of the bridge at mid-thigh level as opposed to hip level. Being some 26m above the wharf, this was quite unnerving.

Upon stepping off and proceeding to the bridge during berthing my foot slipped off the outboard edge. This was due to the fact that there was a gap off approximately 200mm between the platform and the solid upright part of the bridge wing.

The reporter passed the incident to Port State Control who visited the vessel to follow up and conduct a scheduled inspection. They commented that, remarkably, this ship is some 13 years old yet the matter has never been raised. The International Convention on Load Lines 1966, Regulation 25(2) Protection of Crew states that a minimum bulwark height of 1000mm from the deck is required. With the addition of the deck platform the height was reduced to about 880mm which does not comply with this regulation. The vessel's classification society also stipulate that for bridge wings, freeboard decks and superstructure decks, the minimum height of bulwarks must be 1000mm.

Tripping hazards on a bridge wing – height to coaming must be a minimum of 1000mm

A deficiency was raised with a direction to comply with the regulation as soon as practicable. Until then a risk assessment must be completed with appropriate measures taken to ensure there is no risk of falling or tripping hazard to any persons occupying the area. The company's port captain, on board at the time, agreed to follow up accordingly.

The non-compliant design should have been identified in a flag state survey. A risk assessment should have been undertaken and a Management of Change process applied at the design stage. This should have been approved by the ship managers. This report should raise the awareness of all mariners about the need for a minimum bulwark height of 1,000mm, and the inherent dangers of tripping over obstacles at night.

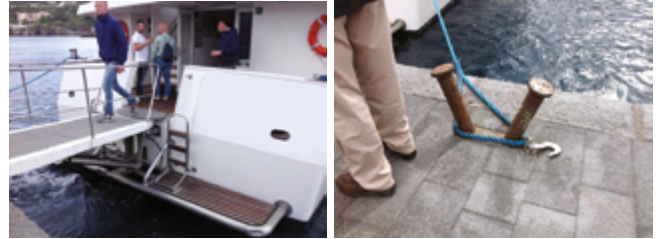
Whilst moored and carrying out administrative tasks on the bridge, I noticed a crew member on the ferry docked nearby, working (painting) on a scaffolding at approximately three to four metres above the deck, without wearing any PPE at all (no safety harness, helmet, safety goggles or gloves). Not only this, but when the scaffolding was moved a few metres by other crew members, the worker stayed on top of it holding onto the rails. A shocking sight indeed!

- Devising an effective means of bridging gaps between the gangway and fixed rails - a barrier that can simply and quickly be put into place and removed - to prevent passengers and crew from falling through these gaps with the associated risks of injury and/or drowning. Crew members were observed not to be wearing life jackets.
- Reviewing their policy for ensuring that methods employed to moor company vessels do not create trip hazards.

The Maritime Advisory Board commented that in both reports the hazards do not appear to have been managed, indicating a poor level of safety culture and leadership. It was questioned whether the “two metre rule” is detracting from the use of a permit to work (which should take into account the specific location of the work, and potential hazards). CSWP Chapters 8, 11, 17 refer. MAIB have investigated several fatalities caused by falls from height, whilst MARS and CHIRP both have reports related to working aloft, so the issue still requires close attention.

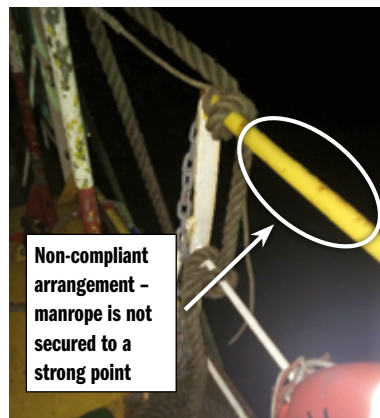
Manropes were secured to handrails rather than strong points on deck as required by SOLAS. This ship may well be in compliance as built, but looking at the rails I would not be happy for them to be protecting me from plummeting to my death. They were quite bent out of shape.

The correct arrangements, including the critical point of transfer from the ladder to deck are fully described in the IMPA – Boarding Arrangements Poster and SOLAS V/23 7.1.1

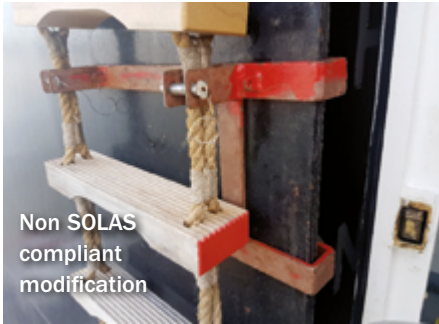
I went to disembark from the ship when my attention was drawn to a device that was clipping the ladder to the hull, arguably to prevent the ladder from sustaining

excessive rotation. The ship had been flagged before for an unsafe pilot ladder arrangement. The solution does not fully comply with SOLAS. The ship (and its Class) need a SOLAS compliant definitive solution to hold the ladder firmly to the hull.

Ref paragraph 7.2.2 (IMO Resolution A1045). Unfortunately, the resolution is not well written as the securing requirements for combination rigs somehow became entangled in the winch reels section during editing - something the MCA picked up earlier this year. However, on close reading of the whole section, it is obvious that the requirements for both the ladder and the accommodation ladder to be secured to the ship’s side apply regardless of a winch reel being utilised.

The Maritime Advisory Board noted that the report should have included the need for a full risk assessment before applying a Management of Change process for improvement – the arrangement put in place does not comply with SOLAS. CHIRP wrote to the vessel’s ISM Manager but they declined to respond. We also discussed the photo with UKMPA who highlighted the following:

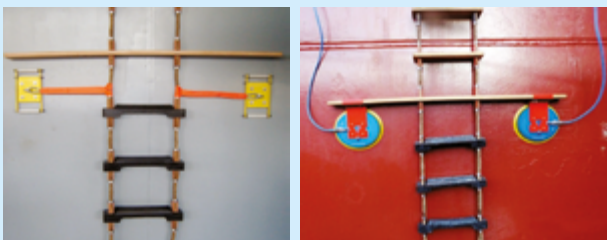
Examples of compliant fitting – magnetic (left) and vacuum (right). Any boarding arrangements for pilots must be in accordance with SOLAS Regulation V/23 & IMO Resolution A.1045(27) as amended by A.1108(29).

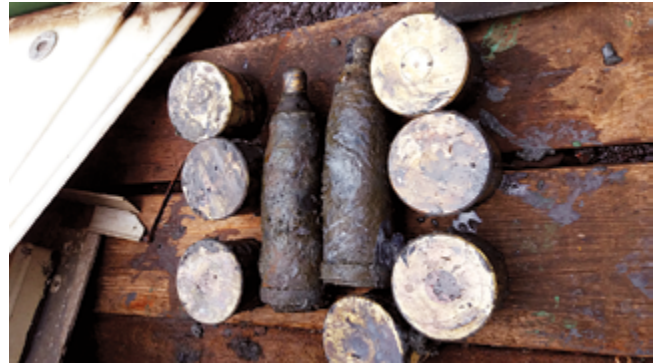
treasure being hunted. The reporter wrote to CHIRP querying the handling of such potentially hazardous materials without proper protective equipment.

Munitions discovered whilst treasure hunting

CHIRP contacted the Royal Navy bomb disposal unit and their advice is quite clear. Under **NO** circumstances are any munitions to be handled. Wherever you are in the world, if suspicious materials are discovered then immediately contact the local authorities in order for their experts to assess and deal with the hazard.

The Maritime Advisory Board, whilst fully endorsing the advice above, commented that discovery of munitions is also common in the dredging and fishing industries. Since the severity of the hazard is unknown, maintaining a safe distance until assistance arrives is prudent.

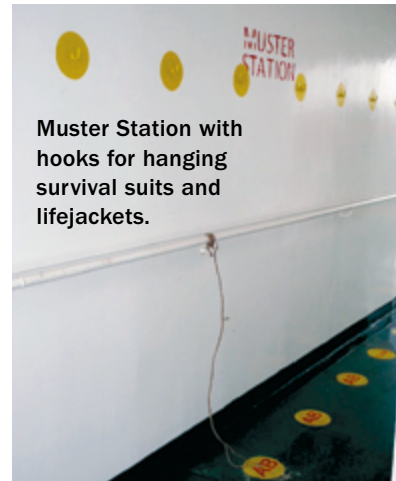
Muster Station with hooks for hanging survival suits and lifejackets.

With reference to **CHIRP** issue No.47 Best Practice – Muster Stations, I attach a picture of my muster station with fixed hooks on the bulkhead to hang each individual's survival suit and lifejacket when they muster. This ensures each seaman collects his designated equipment in an abandon ship situation, bearing in
