NOTE: MARINE HSE safety briefs provide key updates to the content that is available on www.marinehse.co.za. Further they summarise safety matters and incidents, allowing for wider dissemination of information and learning outcomes. The information below has been provided in good faith, with consent and should be reviewed individually by recipients, who should determine its relevance to their own operations. The effectiveness of the MARINE HSE safety brief system depends on receiving resources, articles, incident reports and statistics from companies and individuals, in order to educate and pass on information, and ultimately to avoid repeat incidents. Kindly consider adding MARINE HSE to your internal distribution list for safety briefs and/ or manually submitting information that you consider may be relevant (mark@marinehse.co.za). All incidents and statistics will be published anonymously. Any information, actions, lessons learnt, recommendations and suggestions in MARINE HSE safety briefs are generated by the submitting party or organisation. MARINE HSE safety briefs provide, in good faith, safety information for the benefit of the reader and do not necessarily constitute MARINE

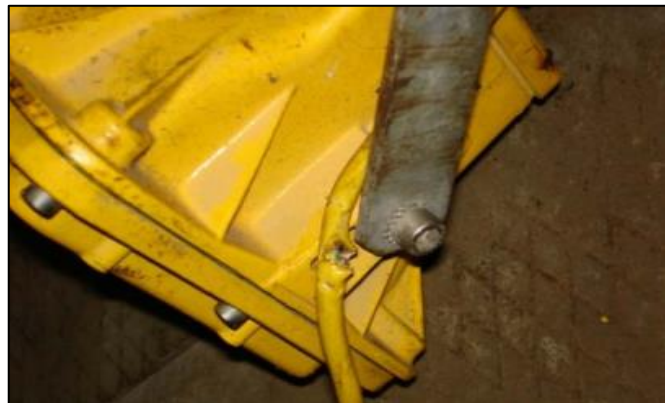
A lamp used to illuminate the worksite was found to be the potential source of electrical shock as the lamp's electrical cord was found to have been damaged.

The damage may have been caused by a pinching action of the cord between the loose mounting bracket of the light and the light housing which was observed to be in contact with the victim's body.

- A ground fault circuit interrupter (GFCI) was not utilised and the circuit breaker failed to trip during the incident;
- The lamp used was designed for permanent exterior mounting and had been modified for use as an interior portable illumination source;
- Sub-contractor personnel had not been effectively supervised;
- An effective pre-job (pre-start) safety discussion had not taken place;
- The approved job safety analysis (JSA) overlooked the potential for electric shock hazards and for cord damage and did not address the actual work that was performed;
- Confined space entry was not considered or included in permits; and
- The hot work permit review process was not effective.

- When using portable electric tools in potentially damp areas, a GFCI (fixed or portable) should be utilised to protect personnel from potential electrical shock;
- All tools and equipment should only be used for their intended and manufacturer's recommended purpose; any change to a tool or equipment's intended purpose should be thoroughly reviewed and approved through an effective management of change process;

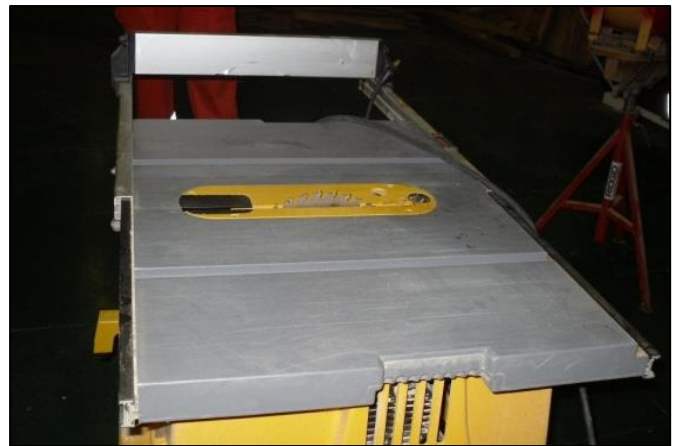
An incident was reported in which a crewman cut off the top of his thumb and his middle finger whilst working with a circular table top bench saw onboard a vessel. The incident occurred when the crewman was cutting 5mm thick plywood with the circular saw in order to make shelving for other plywood pieces. The plywood was laid flat on the bench with the injured person's hands laid flat on top of the plywood, but the plywood snagged and dragged the crewman's right hand towards the spinning blade. The injured person was medivaced ashore by helicopter in a timely manner after immediate first aid onboard had been administered. The surgeons at the local hospital managed to reattach the middle finger but the top of the thumb was lost.

- No risk assessment had been conducted for the operation;
- The equipment was incorrectly set up and incorrectly operated by the injured person, though he stated that he was familiar with the operation of the equipment;
- The bench saw was supplied on board with the necessary safety equipment and full instructions for its safe operation. These instructions included reference to the use of the safety guard, a special tool for pushing the wood through, and the requirement to set the cutting blade to the correct level in accordance with the thickness of the wood that was being cut;
- The instruction manual appeared not to have been available at the workplace and the safety requirements for the safe operation of the saw were either not fully understood or were disregarded;
- There was no guard fitted to the circular saw blade.

- All power tools have the potential to cause serious injury if they are operated incorrectly and without the manufacturers' approved and fitted safety devices;
- A risk assessment must be completed and filed prior to using any power tool. The assessment must take into consideration the following:
 - the competence of the persons using the equipment;
 - the condition of the equipment being used;
 - the provision and proper functioning of adequate safety guards and cut-out devices such as emergency stops and barriers;

- general working environmental conditions such as lighting; and
- availability and condition of any personal protective equipment.
- Guards must always be fitted to equipment when designed to have them in place during operations;
- Power equipment should be operated in accordance with the procedures and rules set for their safe use;
- Full training, manuals and instructions should be available, and manuals and instructions should always be read and fully understood by even experienced operators; and
- Complacency is a serious issue to be guarded against, especially in experienced personnel.

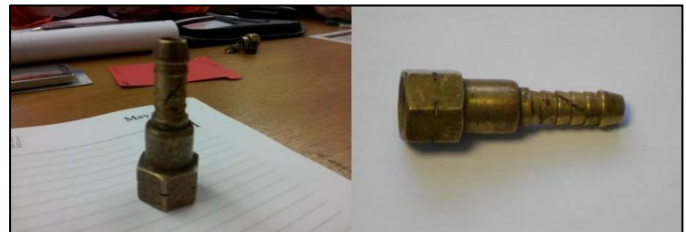
A member has reported an incident in which a small fire caused a minor injury during the use of oxyacetylene cutting equipment. The incident occurred when a welder was using the equipment to cut a piece of steel plate on the deck of the vessel. When the oxygen ran out the welder attached the regulator to a full bottle of oxygen. On reigniting the gas, the oxygen failed to reach the flame. As the welder was attempting to diagnose the fault, the oxygen hose detached from the burner. There was a fire which burned through the leg of his overall and burned his thigh.

- The gas hoses were attached to the burner at check valves with crimped fittings;
- The oxygen check valve was damaged by the effects of the fire;
- The acetylene check valve was still connected to the hose. When the hose was removed it was found to have a deep score across the fitting (see image above). The damage was consistent with the blade of a hacksaw. It appears to have been caused when the hoses were being re-terminated. It was assumed that the oxygen fitting had similar damage which had added to the likelihood of its failure causing the gas release and fire;

- The equipment had been inspected and passed as fit for use by an external agency three weeks prior to the accident. The equipment was only inspected visually and the hoses were not removed to examine the fittings;

- The burning equipment was replaced;
- Instructions were included so that when re-termination takes place, the check valve fittings should be replaced with new fitting; and
- Welders are now required to wear protective overalls appropriate to their work and additional training for welders was provided.
