# THE SINKING OF A SHIP

## COSTA CONCORDIA REVISITED.

# Captain Michael Lloyd, RD\*\*, MNM, CMMar, FNI.

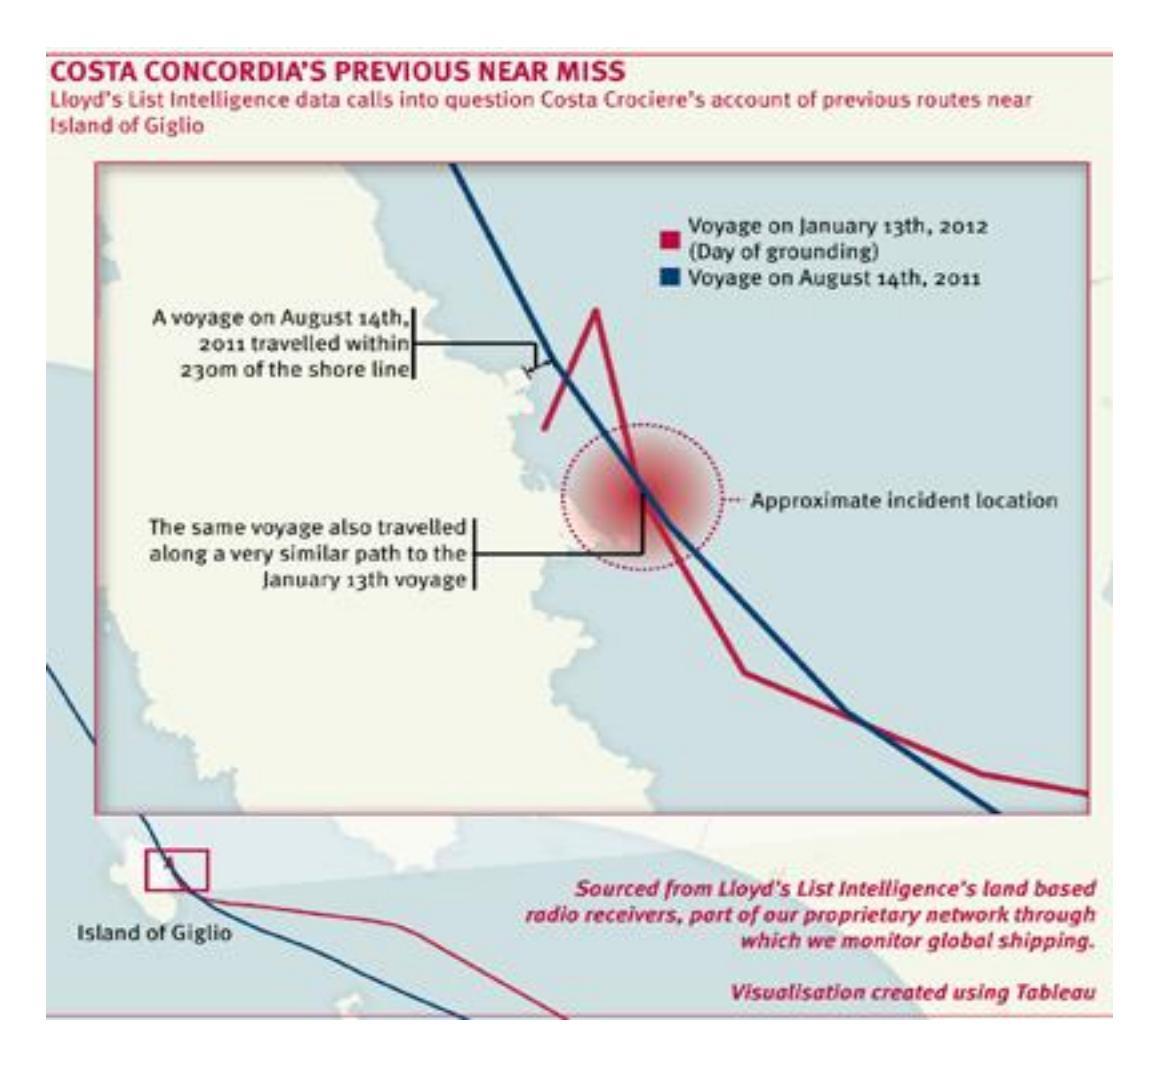
Despite the Company's denials, On August the 14<sup>th</sup> 2011, with authority to do so, the ship under the same Captain made an almost identical pass by the island. The only difference being the angle of approach to the island as the diagram below shows.

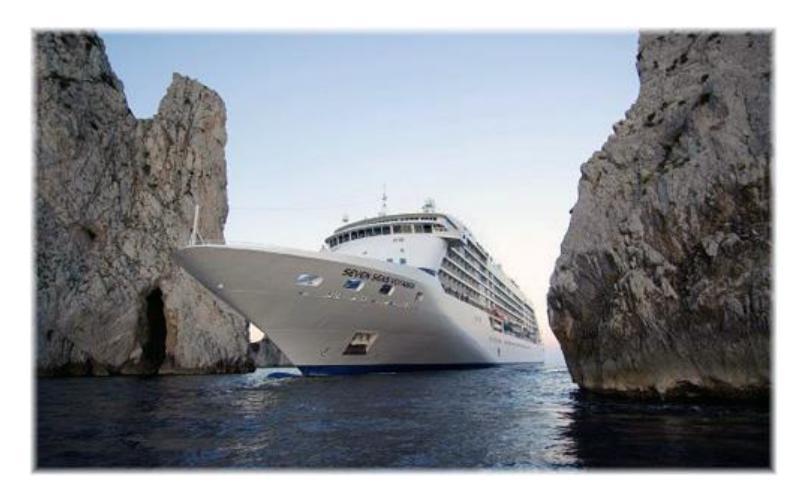
cruise ship Seven Seas Voyager of the American company RSSC. "bowing" to the Faraglioni rocks off the island of Capri.

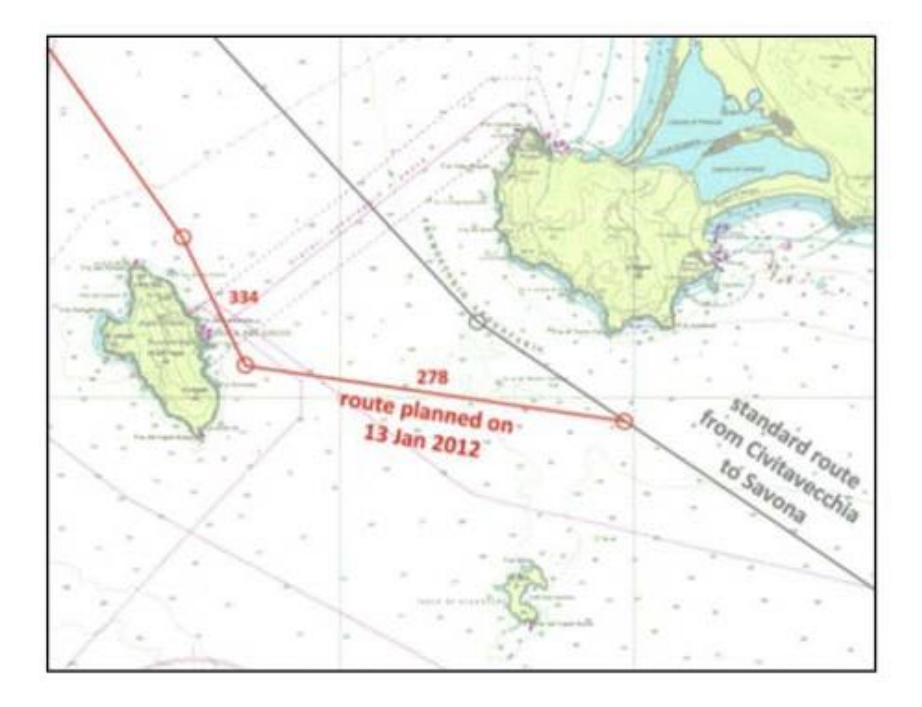
The deviation ordered by Captain Schettino.

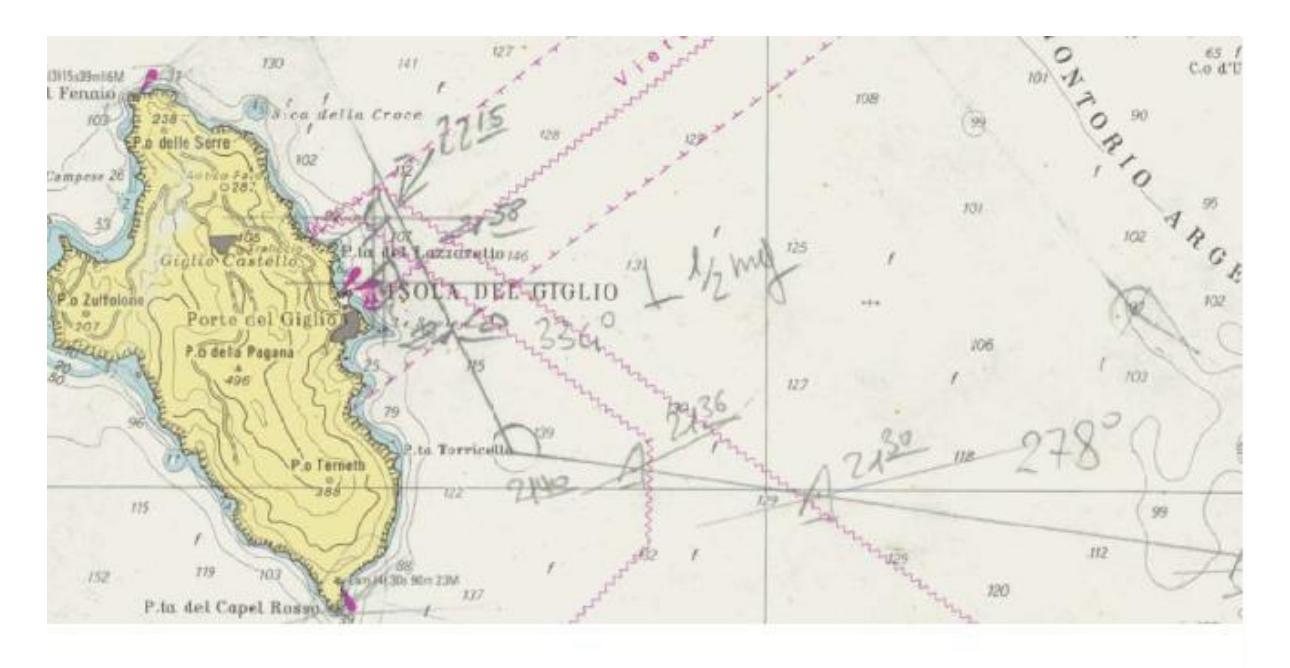
Excerpt of the navigation chart in use on the bridge. The scale on this chart is 1: 100,000 Instead of the correct chart 119 scale 1:20,000. The second officer, as the ships navigation officer, would be responsible to the Captain for the correct charts being available.

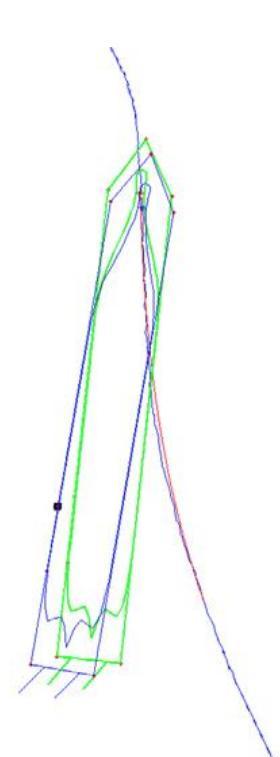
In the figure below, the blue outline represents the actual ship position at impact time while the green outline represents the simulated ship position, without the helmsman's error. The black ellipse represents the rock's position. As can be seen, in this case the left bulkhead of the ships is about 10m from the rock. One could safely state that, according to the simulator, the ship would have passed close to the rock without impacting or, considering the worst case for the simulation error and model approximations, the impact could have occurred about 18mbehind.

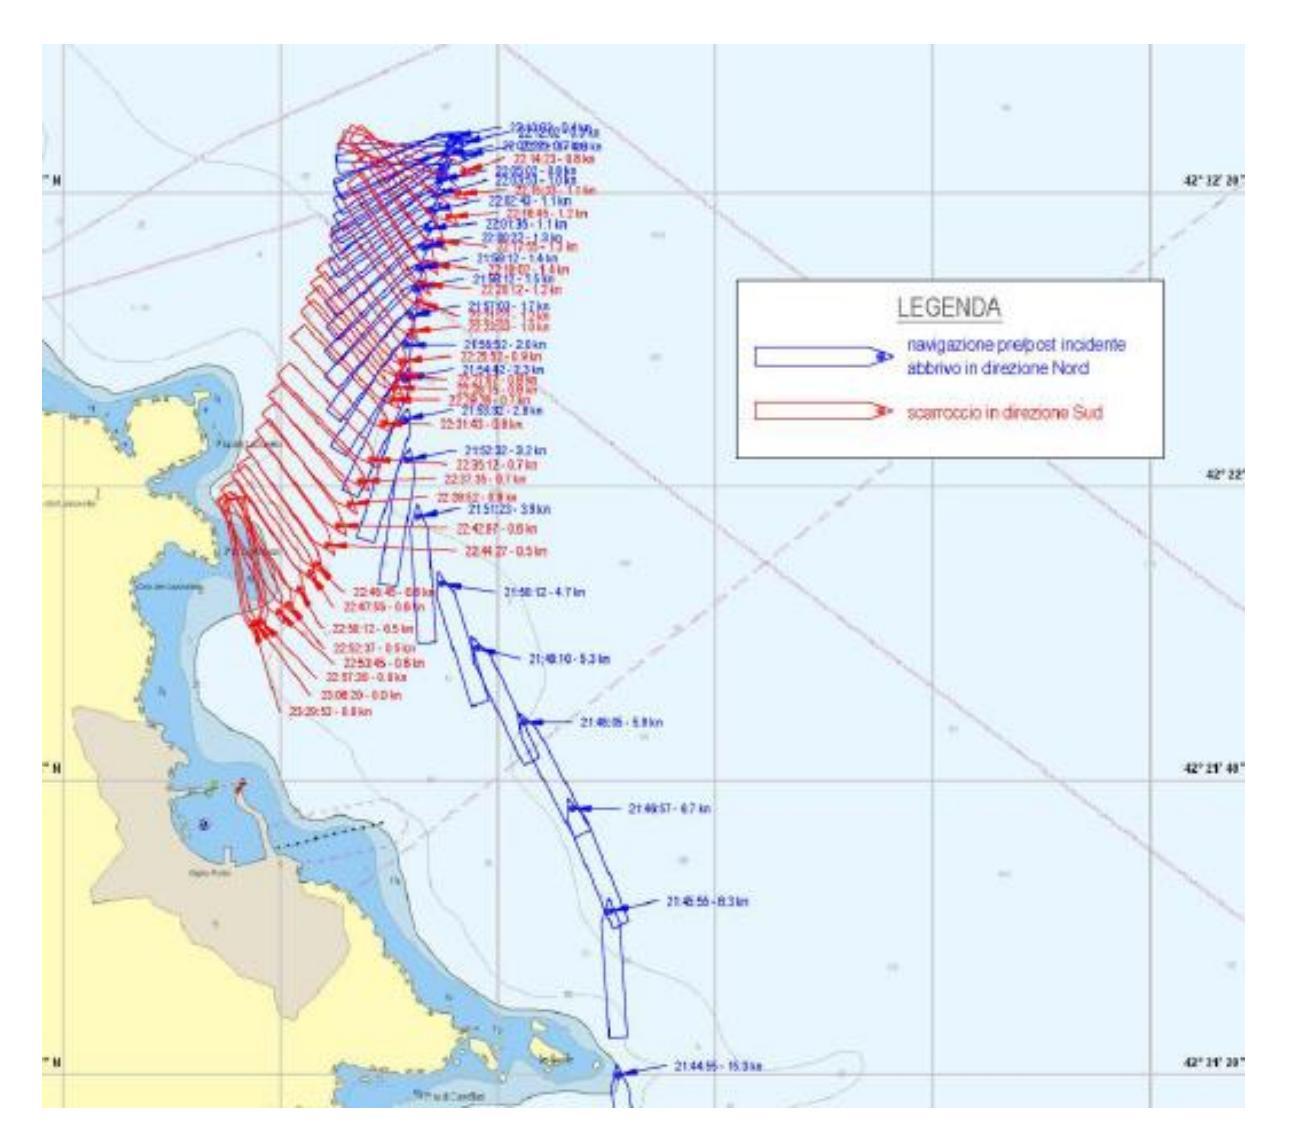
Track of the ship after the grounding. The Blue track is the ships continuing course. to the North. As the momentum of the course and speed following the collision gradually ceases, the effects of current and wind gradually control the ship and she drifts South West as shown in red.

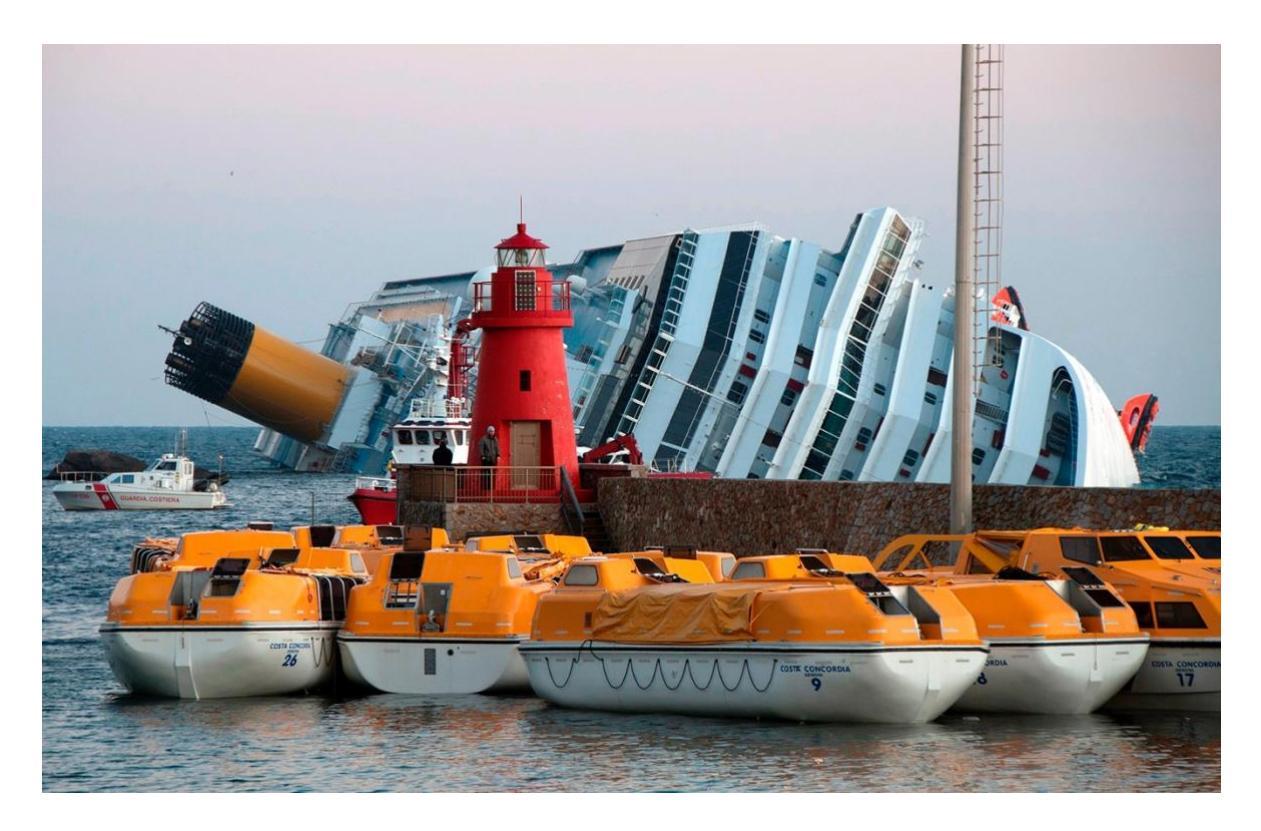
Lifeboats in Giglio Harbour the next day.
