# THE SINKING OF A SHIP

## COSTA CONCORDIA REVISITED.

# Captain Michael Lloyd, RD\*\*, MNM, CMMar, FNI.

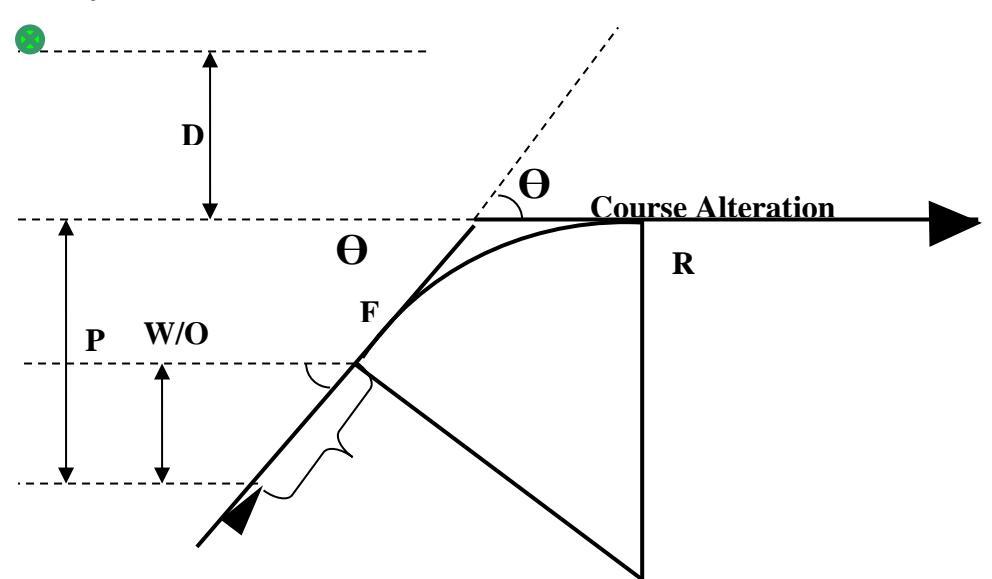
Wheel over positions can be found from the ship's manoeuvring data. These are of special importance when making passage in rivers or channels. Most ships have ready for use pre calculated distances based on speed, degree of helm required, degree of turn and draft. F = Head Reach - Distance travelled by vessel after giving wheel over & before commencing turn, i.e. distance to overcome inertia.

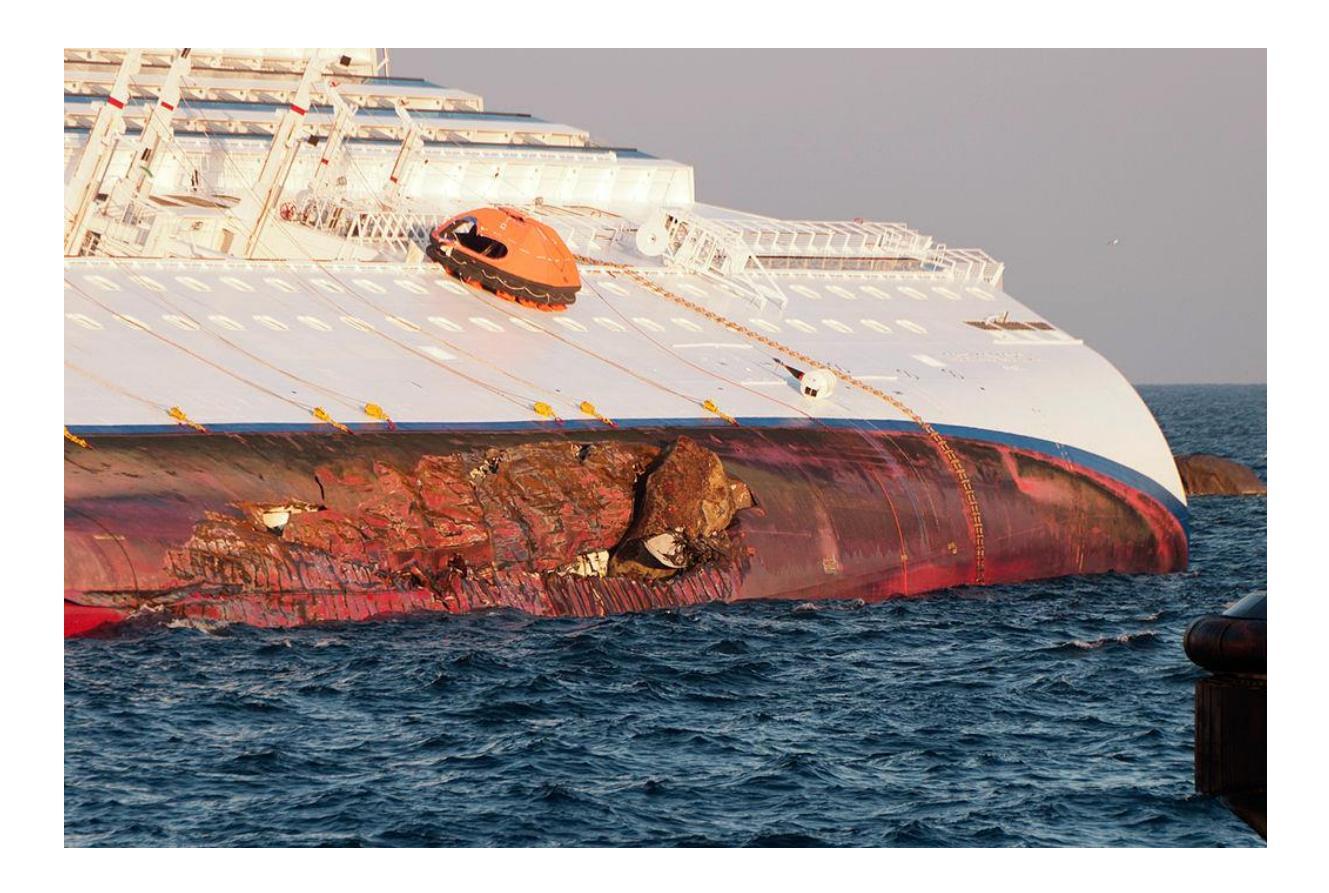
After the collision with the rocks, the ship gradually lost her own momentum and, without power to her engines and steering became subject to the wind and the current. Very fortunately, this took the ship back to ground for a second time close to the small harbour.

The damage was catastrophic, although unknown at the time. The ship had been built to SOLAS 90 regulations which specified that the number of flooded compartments the vessel would survive would be 2.
